Manhole Inspection Summary

Manhole # S17G__018MH

Inspection ☐ Is Incomplete Rating: **4) Poor**

Location Address: **101 WARWICK AVE**

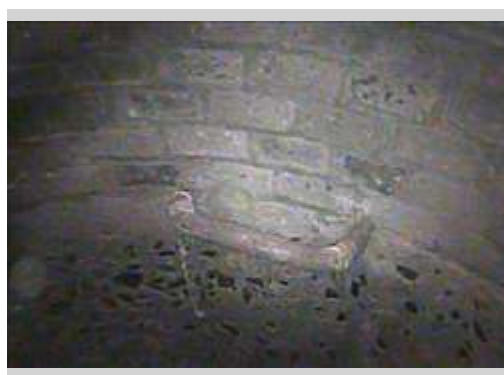
Defect 4

☒ **Evidence Of Surcharge**

Depth: **4** (ft.) ☐ Active Surcharge Present

SURCHARGE EVIDENCE ON THE STEP

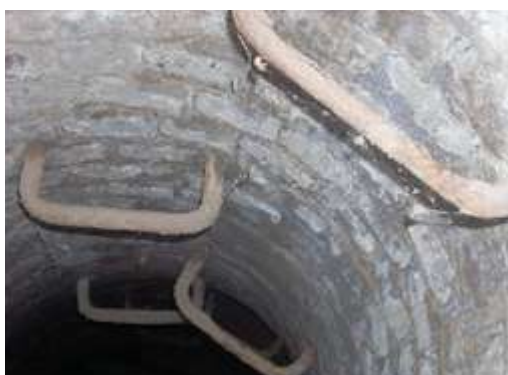
Defect 3

Count: **9** Missing: **0** ☒ **Corroded**

CORRODED STEPS

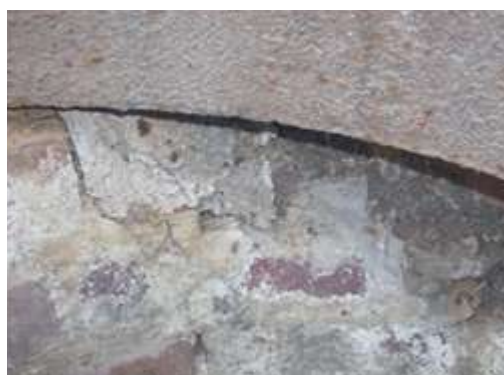
Defect 2

Condition: ☐ Sound ☒ **Cracked** ☐ Root Intrusion ☐ Loose Brick ☒ **Deteriorated**

DETERIORATED AND CRACKED CORBEL

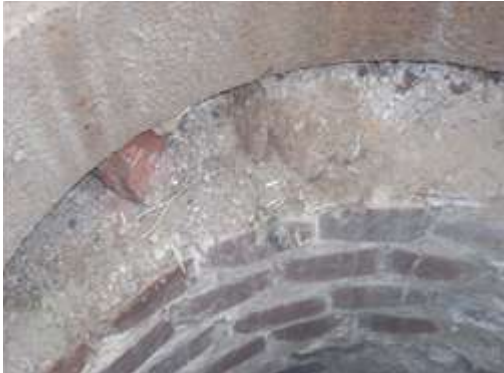
Defect 1

Offset: **1** (in.)

FRAME OFFSET

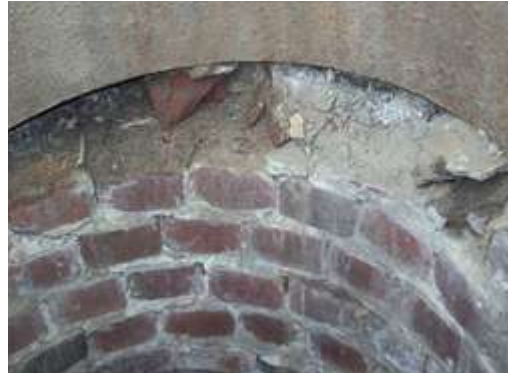
Defect 6

Comments **ORIGINALLY INSPECTED 3-20-08. TOOK NEW PHOTO TO SHOW
CRACKED/DETERIORATED CHIMNEY 1/2/09**

Condition: ☐ Sound ☒ **Cracked** ☐ Root Intrusion ☒ **Loose Brick** ☒ **Deteriorated**

LOOSE CRACKED AND DETERIORATION
OF CHIMNEY

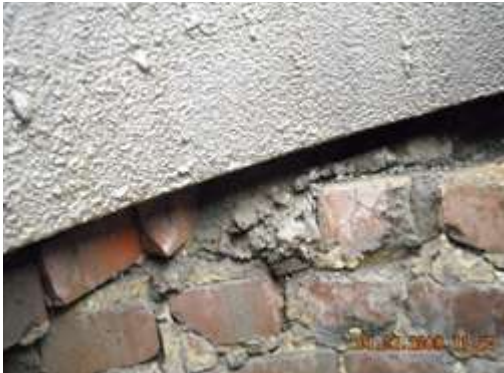
Defect 5

CRACKED AND LOOSE BRICKS IN
DETERIORATED CHIMNEY

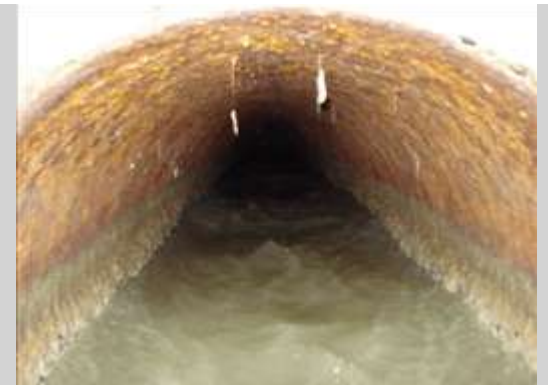
6 O'Clock Inflow

Infiltration: **None** Pipe Seal Cond: **Cracked**

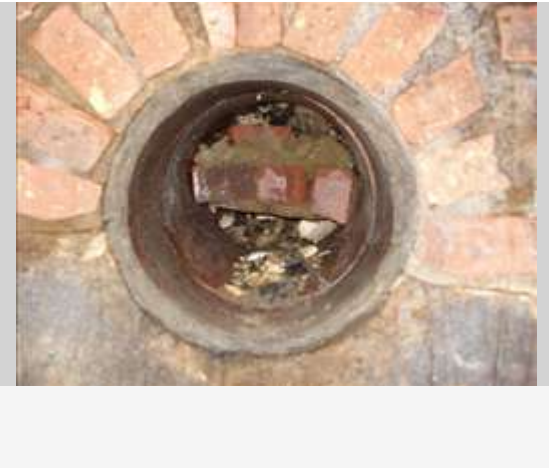
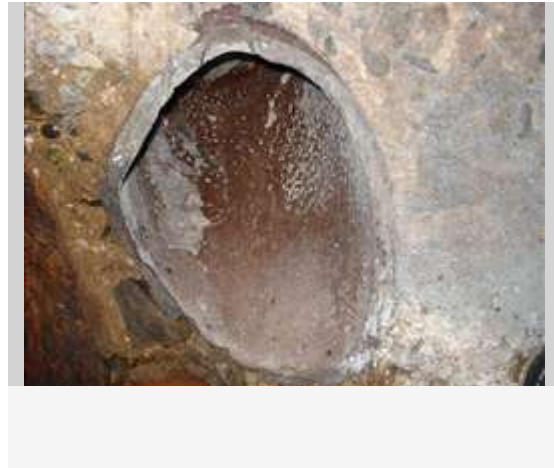
7 O'Clock Inflow

Deposits: ☐ None ☐ Mud ☐ Sludge ☒ **Debris** ☐ Grease

Silt Depth: **1** (in.) Deposits Extent: **Light**
